Scenario 1

Scenario 2 - Background

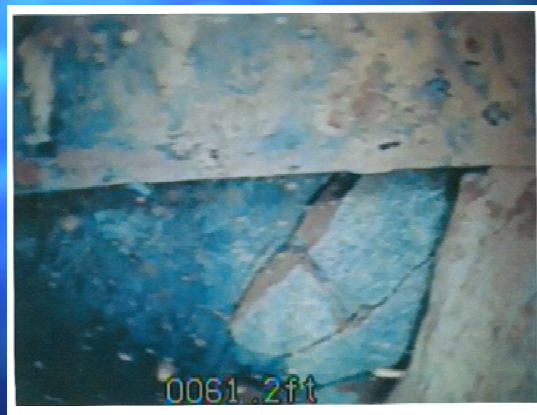
Casing Shoe

- Stream and Well were physically and chemically different
- Problems with well integrity
