Scenario 1

Scenario 2 - Background

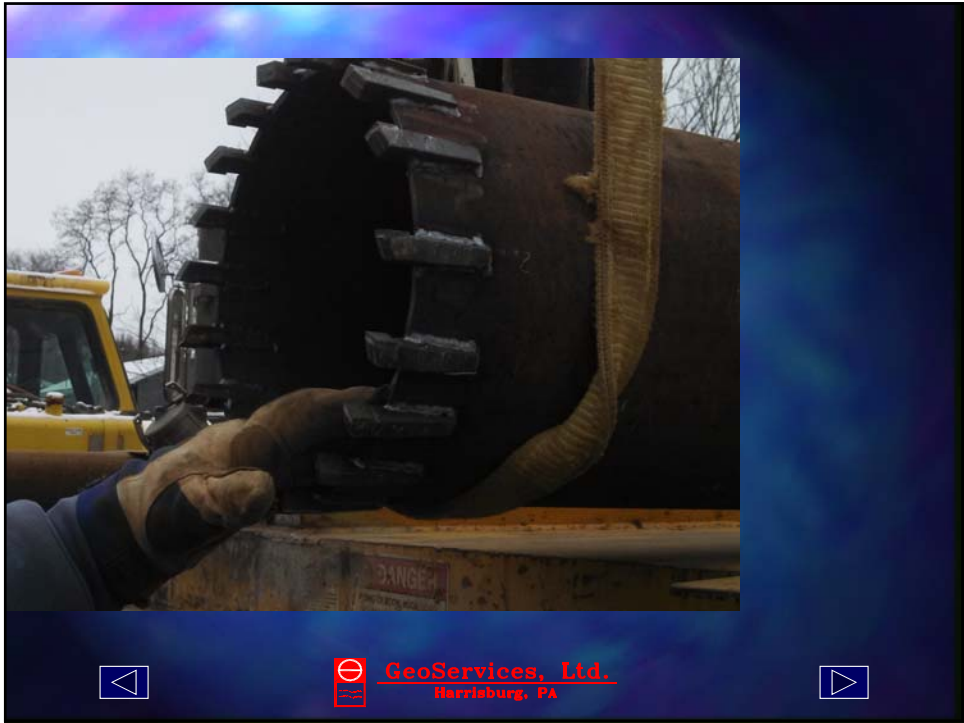
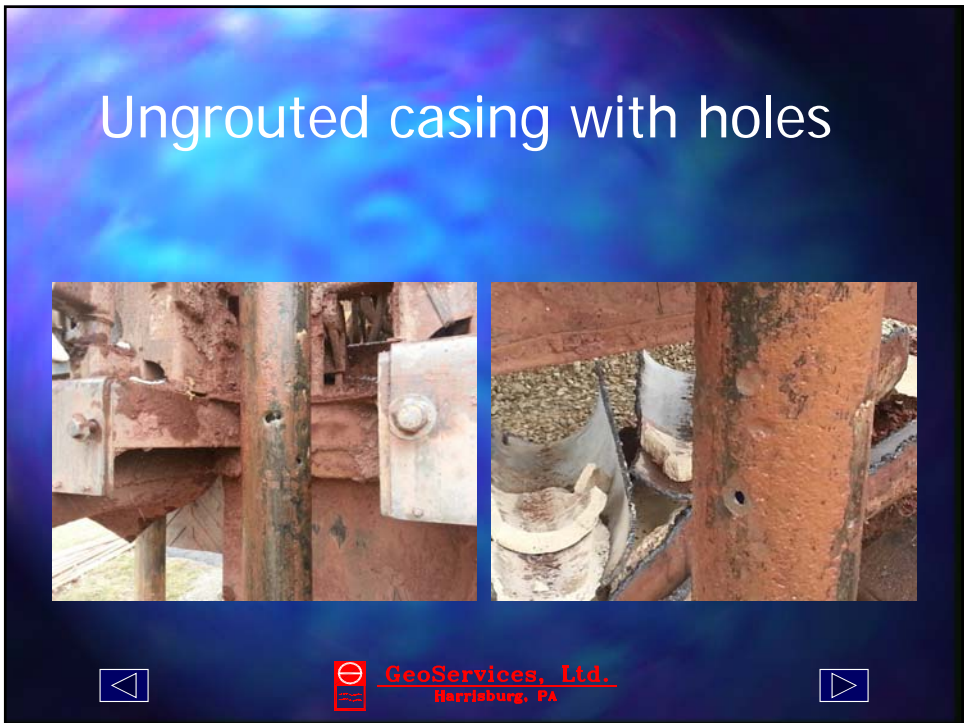
Well Log

- Consider current construction
- Consider needs and options for pump and appurtenances
- Can't line well; already 6-inch
- Only option – remove casing
- 20 feet of ten inch with ~ 43 feet of 6-inch
- Grouted

- Set casing deeper to eliminate suspected shallow contamination
- Clear with DEP that we could reconstruct without losing grandfathered status – Not deepen or drill new water bearing zones

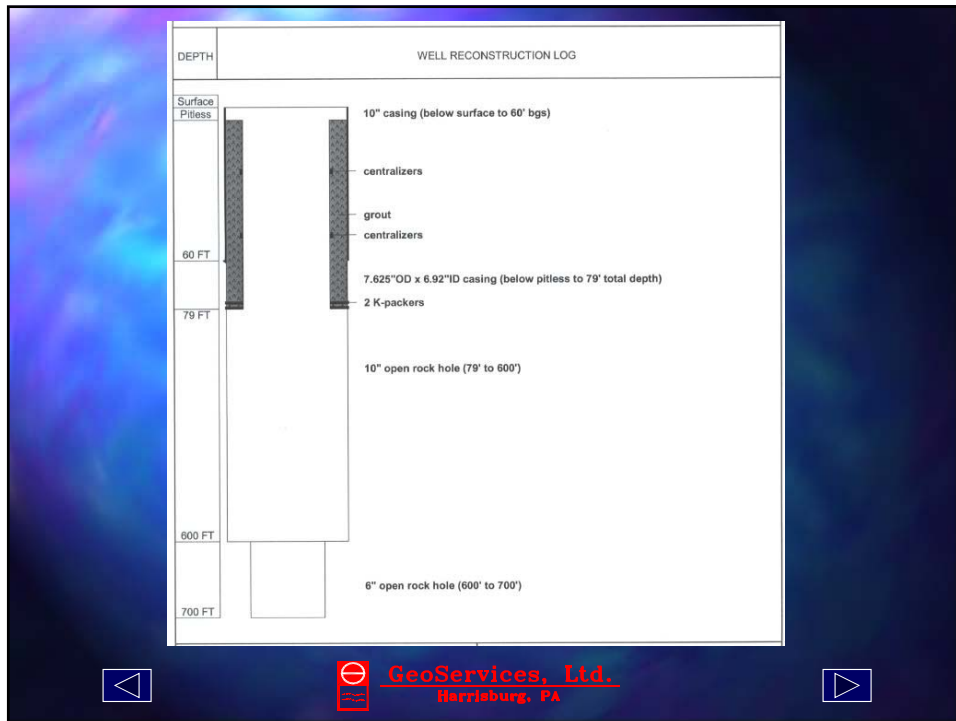
Casing Liner

- Stream and Well were physically and chemically different
- Problems with well integrity
